**Flood Control Project Maintenance  
Levee Inspections**

**Fall 2018 Levee Maintenance Deficiency Summary Report**

**Sacramento River Basin**

**Butte County Department of Public Works**

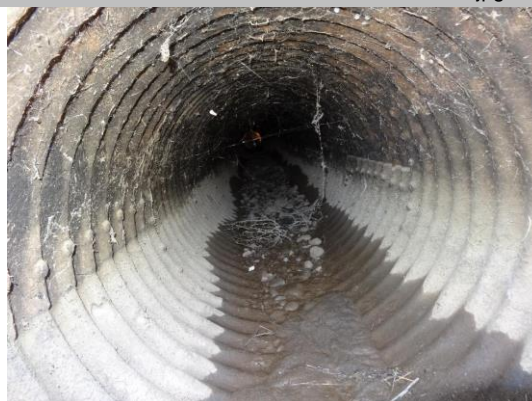
Photo 3 of 3 : UCIP\_FA\_2018\_31864\_58067.jpg

LM Start	3.34	Rating **	M	Issue No.	35 (cont)	
LM End	3.34	Issue Type +	Ma	Location *		
Category	Supplemental			GPS Latitude/Longitude		
				Start	End	
Item	DWR UCIP LMA Responsibility			39.777410 °	39.777410 °	
				-121.849627 °	-121.849627 °	
DWR ID	19271					
Comment Code						
Inspector Comment						
FS_ID:31864 DS_ID:19271 EP_NO: N/A Repair Type: Non-Urgent Crossing Status: Found UCIP Comments: Needs cleaning and clearing the culvert. FIELD_STRUCT_DESC: 24-inch corrugated metal gravity drainage pipe through the levee, 10.5 feet below the crown. Flap gate on the waterside (WS) end. Concrete U-shaped headwall on each end. Grouted riprap apron on the landside (LS) end. Grouted riprap spillway on the WS end. [Additional Reference(s): DWR Levee Log, 1992. USACE Sacramento O&M Manual 504, May 1965, (HLM 3.43)]. FS Date: 3/7/2014

LS view: inside view of CMP on levee slope. Needs cleaning and clearing.

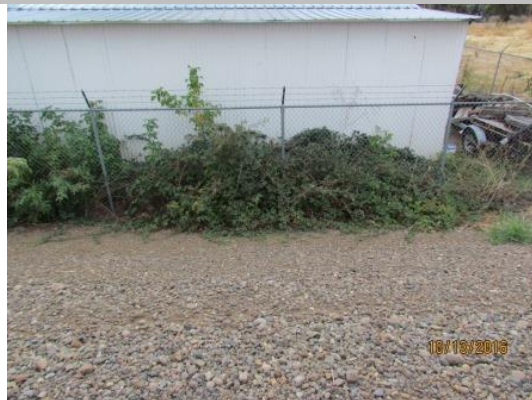
Photo 1 of 1 : FA\_2018\_NA0003\_68\_20\_20180905\_00006.jpg

LM Start	0.16	Rating **	M	Issue No.	20
LM End	0.16	Issue Type +	Ma	Location *	LS
Category	Earthen Levee			GPS Latitude/Longitude	
				Start	End
Item	Vegetation			39.776526 °	39.776526 °
				-121.848727 °	-121.848727 °
DWR ID	DWR_NA0003_04_f_2016_20				
Comment Code					
V2 : Remove the wild growth other than native grasses from the levee slopes.					
Inspector Comment

View of the vegetation along the landside toe blocking visibility.

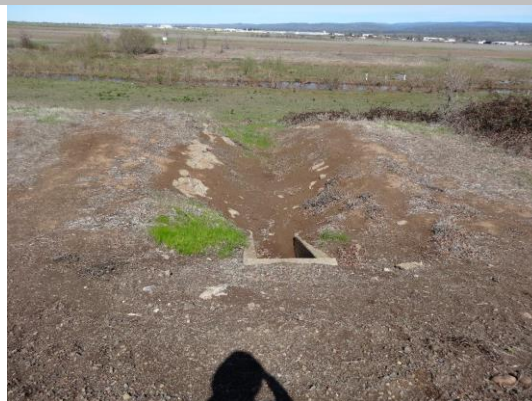
Photo 1 of 3 : UCIP\_FA\_2018\_32026\_58520.jpg

LM Start	0.27	Rating **	M	Issue No.	25
LM End	0.27	Issue Type +	Ma	Location *	
Category	Supplemental			GPS Latitude/Longitude	
				Start	End
Item	DWR UCIP LMA Responsibility			39.776554 °	39.776554 °
				-121.850730 °	-121.850730 °
DWR ID	19279				
Comment Code					
Inspector Comment					
FS_ID:32026					
DS_ID:19279					
EP_NO: N/A					
Repair Type: Non-Urgent					
Crossing Status: Found					
UCIP Comments: Needs cleaning and clearing the culvert.					
FIELD_STRUCT_DESC: 24-inch corrugated metal gravity drainage pipe through the levee, 10 feet below the crown. Flap gate on the waterside (WS) end. Concrete U-shaped headwall on each end. Grouted riprap apron on the landside (LS) end. Grouted riprap spillway on the WS end. [Additional Reference(s): DWR Levee Log, 1992. USACE Sacramento O&M Manual 504, May 1965, (HLM 0.28)].					
FS Date: 3/7/2014

WS view: concrete headwall and grouted riprap spillway on levee slope.

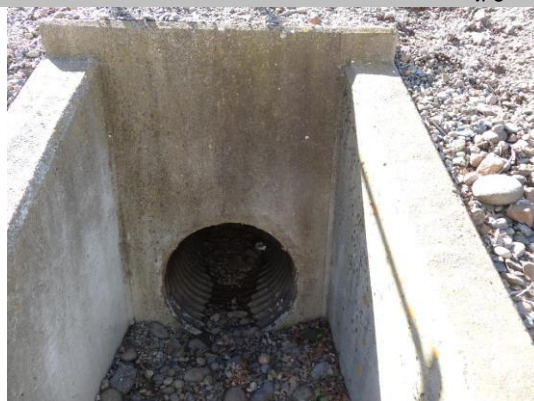
Photo 2 of 3 : UCIP\_FA\_2018\_32023\_58504.jpg

LM Start	0.35	Rating **	M	Issue No.	27 (cont)	
LM End	0.35	Issue Type +	Ma	Location *		
Category	Supplemental			GPS Latitude/Longitude		
				Start		End
Item	DWR UCIP LMA Responsibility			39.775682 °		39.775682 °
				-121.850375 °		-121.850375 °
DWR ID	19281					
Comment Code						
Inspector Comment						
FS_ID:32023 DS_ID:19281 EP_NO: N/A Repair Type: Non-Urgent Crossing Status: Found UCIP Comments: Needs cleaning and clearing the culvert. FIELD_STRUCT_DESC: 24-inch corrugated metal gravity drainage pipe through the levee, 8 feet below the crown. Flap gate on the waterside (WS) end. Concrete U-shaped headwall on each end. Grouted riprap apron on the landside (LS) end. Grouted riprap spillway on the WS end. [Additional Reference(s): DWR Levee Log, 1992. USACE Sacramento O&M Manual 504, May 1965, (HLM 0.36)]. FS Date: 3/7/2014

LS view: U type concrete headwall and CMP on levee slope. Pebbles and mud on inlet box.

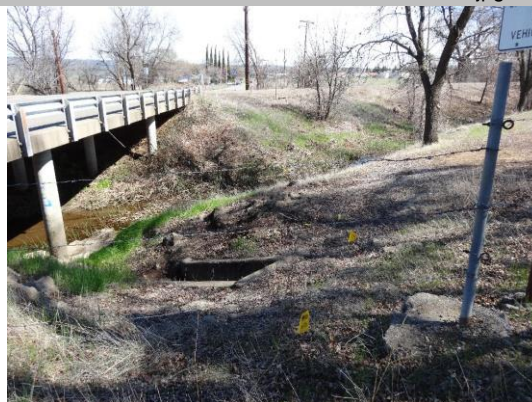
Photo 1 of 2 : UCIP\_FA\_2018\_31946\_58357.jpg

LM Start	0.92	Rating **	M	Issue No.	29
LM End	0.92	Issue Type +	En	Location *	
Category	Supplemental			GPS Latitude/Longitude	
				Start	End
Item	DWR UCIP Field Study			39.775729 °	39.775729 °
				-121.850950 °	-121.850950 °
DWR ID	19293				
Comment Code					
Inspector Comment					
FS_ID:31946 DS_ID:19293 EP_NO: 15950 Repair Type: Non-Urgent Crossing Status: Indicator Found UCIP Comments: Only little gasoline indicator flags found on both sides of the levee and across the creek. FIELD_STRUCT_DESC: 6-inch high-pressure natural gas main line of an unknown material through both levees and under Dry Creek, 2 feet below the crown. (Plans to place a 6-inch high-pressure gas main under both levees and creek bed to a depth of 5 feet across Dry Creek authorized under Permit No. 15950, 1992 - Pacific Gas and Electric Company [PG&E]). FS Date: 3/7/2014

WS view: little gasoline indicator (yellow flags) on both sides of the levee.

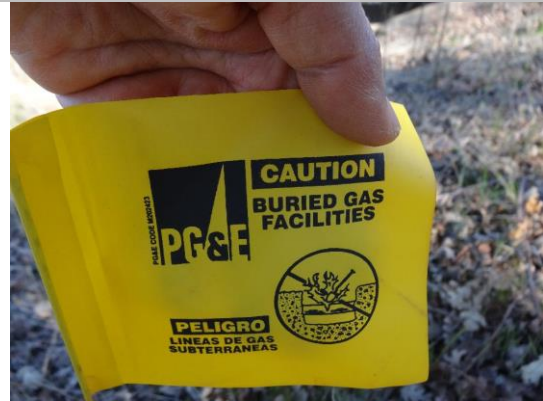
Photo 2 of 2 : UCIP\_FA\_2018\_31946\_58356.jpg

LM Start	0.92	Rating **	M	Issue No.	29 (cont)
LM End	0.92	Issue Type +	En	Location *	
Category	Supplemental			GPS Latitude/Longitude	
				Start	End
Item	DWR UCIP Field Study			39.775729 °	39.775729 °
				-121.850950 °	-121.850950 °
DWR ID	19293				
Comment Code					
Inspector Comment					
FS_ID:31946 DS_ID:19293 EP_NO: 15950 Repair Type: Non-Urgent Crossing Status: Indicator Found UCIP Comments: Only little gasoline indicator flags found on both sides of the levee and across the creek. FIELD_STRUCT_DESC: 6-inch high-pressure natural gas main line of an unknown material through both levees and under Dry Creek, 2 feet below the crown. (Plans to place a 6-inch high-pressure gas main under both levees and creek bed to a depth of 5 feet across Dry Creek authorized under Permit No. 15950, 1992 - Pacific Gas and Electric Company [PG&E]). FS Date: 3/7/2014

WS view: close up view of little gasoline indicator.

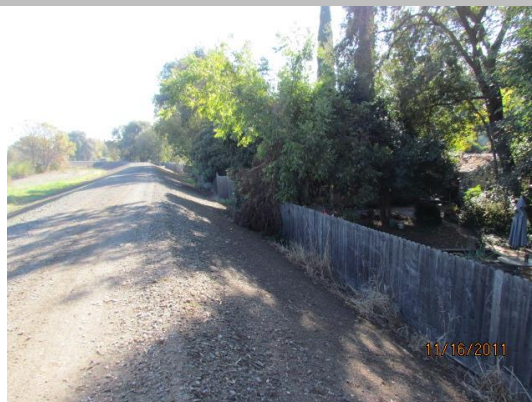
Photo 1 of 1 : FA\_2018\_NA0003\_68\_3\_20180905\_00003.jpg

LM Start	1.11	Rating **	U	Issue No.	3
LM End	1.22	Issue Type +	En	Location *	LS
Category	Earthen Levee			GPS Latitude/Longitude	
				Start	End
Item	Encroachments			39.776760 °	39.777650 °
				-121.854022 °	-121.855687 °
DWR ID	DWR_NA0003_04_s_2012_3				
Comment Code					
FE : Fence					
Inspector Comment

View of the fence along the landside toe.

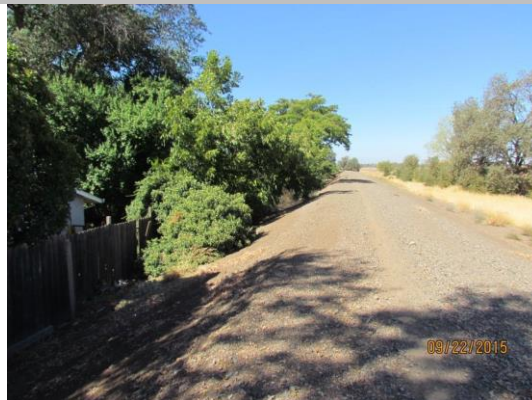
Photo 1 of 1 : FA\_2018\_NA0003\_68\_17\_20180905\_00004.jpg

LM Start	1.16	Rating **	M	Issue No.	17
LM End	1.22	Issue Type +	Ma	Location *	LS
Category	Earthen Levee			GPS Latitude/Longitude	
				Start	End
Item	Trim / Thin Trees			39.777128°	39.777580°
				-121.854763°	-121.855612°
DWR ID	DWR_NA0003_04_f_2015_17				
Comment Code					
T1 : Trim trees to at least five feet above ground level.					
Inspector Comment					
Remove the trees that are overhanging the levee slope.

View of the trees overhanging the levee slope.

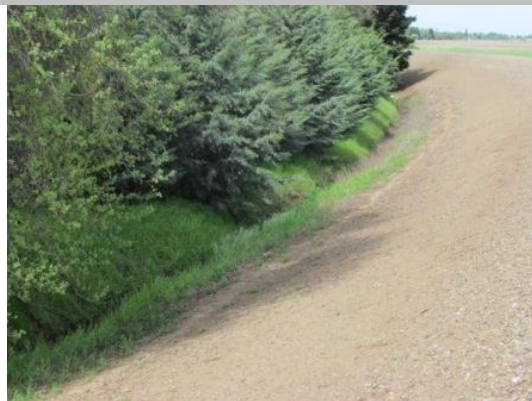
Photo 1 of 1 : FA\_2018\_NA0003\_68\_2\_20180905\_00002.jpg

LM Start	1.27	Rating **	M	Issue No.	2
LM End	1.36	Issue Type +	En	Location *	LS
Category	Earthen Levee			GPS Latitude/Longitude	
				Start	End
Item	Encroachments			39.778003 °	39.778378 °
				-121.856403 °	-121.857953 °
DWR ID	DWR_NA0003_04_s_2012_2				
Comment Code					
DT : Ditch					
Inspector Comment

View of ditch at the landside toe.

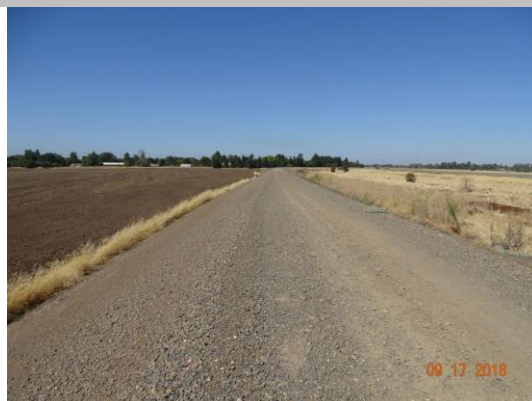
Photo 1 of 1 : FA\_2018\_NA0003\_68\_16\_20181001\_00039.jpg

LM Start	1.60	Rating **	A	Issue No.	16
LM End	1.60	Issue Type +	Ma	Location *	LS
Category	Earthen Levee			GPS Latitude/Longitude	
				Start	End
Item	Vegetation			39.778768 °	39.778768 °
				-121.862573 °	-121.862573 °
DWR ID	DWR_NA0003_04_f_2018_16				
Comment Code					
V1 : Control annual grass and weeds on the levee slopes and easements.					
Inspector Comment					
The vegetation has been removed from both slopes.

View of no vegetation on both slopes.

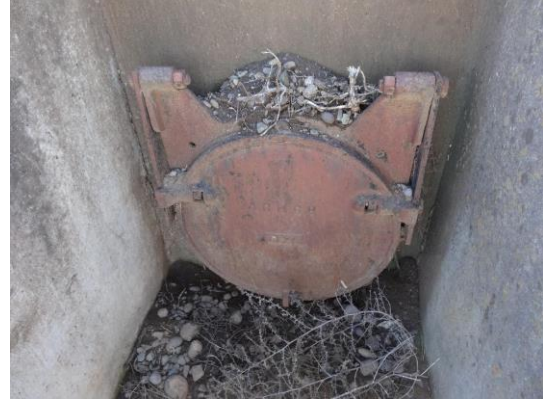
Photo 1 of 3 : UCIP\_FA\_2018\_31965\_58395.jpg

Comment Code						
Inspector Comment						
FS_ID:31965						
DS_ID:19291						
EP_NO: N/A						
Repair Type: Non-Urgent						
Crossing Status: Found						
UCIP Comments: Needs cleaning and clearing the culvert.						
FIELD_STRUCT_DESC: 24-inch corrugated metal gravity drainage pipe						
through the levee, 11 feet below the crown. Flap gate on the waterside						
(WS) end. Concrete U-shaped headwall on each end. Grouted riprap						
apron on the landside (LS) end. Grouted riprap spillway on the WS end.						
[Additional Reference(s): DWR Levee Log, 1992. USACE Sacramento						
O&M Manual 504, May 1965, (HLM 2.22)].						
FS Date: 3/7/2014

WS view: U type concrete headwall and CMP on levee slope. Vegetation debris and mud in outlet box. Needs cleaning and clearing.

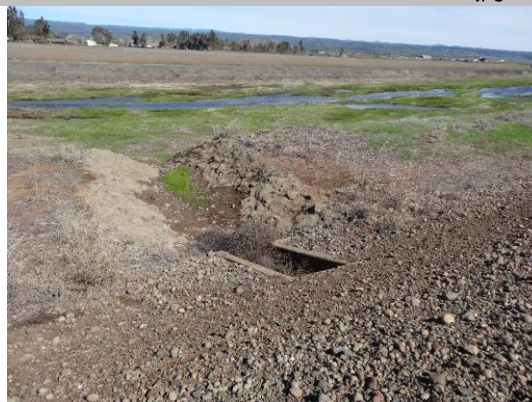
Photo 1 of 3 : UCIP\_FA\_2018\_31966\_58401.jpg

LM Start	2.47	Rating **	M	Issue No.	34
LM End	2.47	Issue Type +	Ma	Location *	
Category	Supplemental			GPS Latitude/Longitude	
				Start	End
Item	DWR UCIP LMA Responsibility			39.784244 °	39.784244 °
				-121.876810 °	-121.876810 °
DWR ID	19292				
Comment Code					
Inspector Comment					
FS_ID:31966 DS_ID:19292 EP_NO: N/A Repair Type: Non-Urgent Crossing Status: Found UCIP Comments: Needs cleaning and clearing the culvert. FIELD_STRUCT_DESC: 24-inch corrugated metal gravity drainage pipe through the levee, 11 feet below the crown. Flap gate on the waterside (WS) end. Concrete U-shaped headwall on each end. Grouted riprap apron on the landside (LS) end. Grouted riprap spillway on the WS end. [Additional Reference(s): DWR Levee Log, 1992. USACE Sacramento O&M Manual 504, May 1965, (HLM 2.56)]. FS Date: 3/7/2014

WS view: U type concrete headwall and grouted riprap spillway on levee slope.

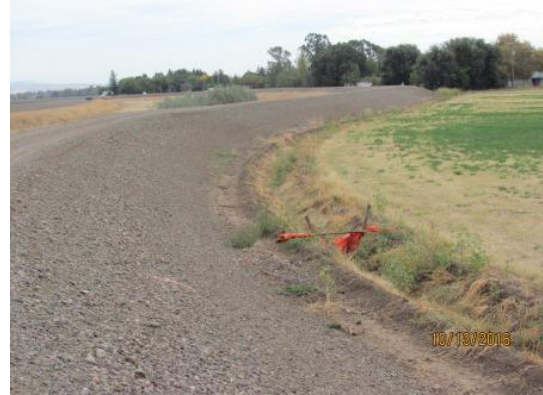
Photo 1 of 1 : FA\_2018\_NA0003\_68\_24\_20180905\_00010.jpg

LM Start	2.49	Rating **	M	Issue No.	24
LM End	2.61	Issue Type +	En	Location *	LS
Category	Earthen Levee			GPS Latitude/Longitude	
				Start	End
Item	Encroachments			39.784408 °	39.785619 °
				-121.877053 °	-121.878604 °
DWR ID	DWR_NA0003_04_f_2016_24				
Comment Code					
DT : Ditch					
Inspector Comment

View of a ditch along the landside toe.

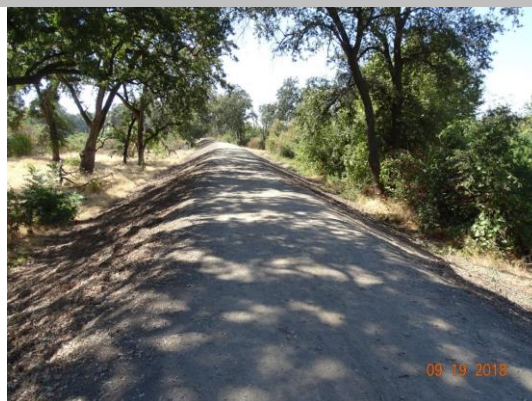
Photo 1 of 1 : FA\_2018\_NA0003\_69\_4\_20181001\_00007.jpg

LM Start	0.26	Rating **	A	Issue No.	4
LM End	0.47	Issue Type +	Ma	Location *	LS
Category	Earthen Levee			GPS Latitude/Longitude	
				Start	End
Item	Vegetation			39.761850 °	39.761370 °
				-121.793822 °	-121.797223 °
DWR ID	DWR_NA0003_05_f_2018_4				
Comment Code					
V1 : Control annual grass and weeds on the levee slopes and easements.					
Inspector Comment					
The vegetation was removed from both slopes.

View of no vegetation on both slopes.

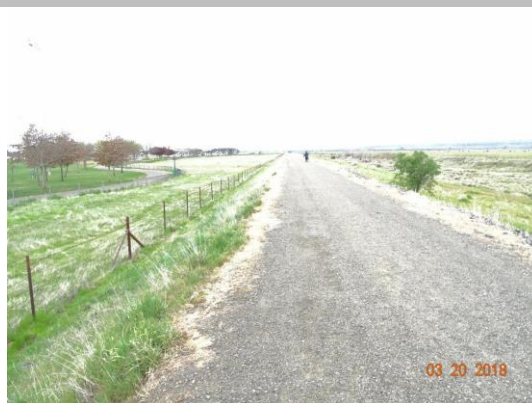
Photo 1 of 2 : FA\_2018\_NA0003\_69\_14\_20180905\_00004.jpg

LM Start	0.85	Rating **	A	Issue No.	14
LM End	1.85	Issue Type +	Ma	Location *	LS
Category	Earthen Levee			GPS Latitude/Longitude	
				Start	End
Item	Vegetation			39.764702 °	39.775426 °
				-121.803562 °	-121.814201 °
DWR ID	DWR_NA0003_05_f_2017_14				
Comment Code					
V2 : Remove the wild growth other than native grasses from the levee slopes.					
Inspector Comment					
There are native grasses on both slopes.

View of the levee with native vegetation on both slopes.

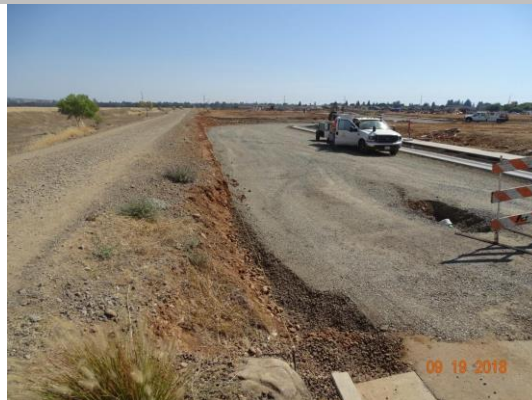
Photo 1 of 2 : FA\_2018\_NA0003\_69\_15\_20181001\_00008.jpg

LM Start	1.56	Rating **	U	Issue No.	15
LM End	1.56	Issue Type +	En	Location *	LS
Category	Earthen Levee			GPS Latitude/Longitude	
				Start	End
Item	Encroachments			39.772190 °	39.772190 °
				-121.810700 °	-121.810700 °
DWR ID	DWR_NA0003_05_f_2017_15				
Comment Code					
RW : Retaining Wall					
Inspector Comment					
The developer cut a paved road, gutter and large rocks in slope/toe of the levee. I asked Butte County Public Works to send the developer an enforcement letter regarding this encroachment. Butte County is meeting with the developer to resolve this issue.

View of the housing track road cutting into the levee toe.

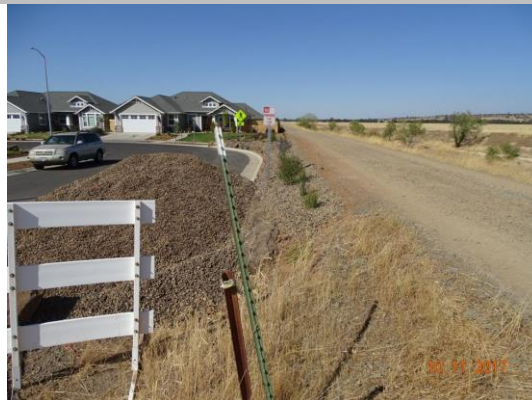
Photo 2 of 2 : FA\_2018\_NA0003\_69\_15\_20180905\_00006.jpg

LM Start	1.56	Rating **	U	Issue No.	15 (cont)	
LM End	1.56	Issue Type +	En	Location *	LS	
Category	Earthen Levee			GPS Latitude/Longitude		
				Start		End
Item	Encroachments			39.772190 °		39.772190 °
				-121.810700 °		-121.810700 °
DWR ID	DWR_NA0003_05_f_2017_15					
Comment Code						
RW : Retaining Wall						
Inspector Comment						
The developer cut a paved road, gutter and large rocks in slope/toe of the levee. I asked Butte County Public Works to send the developer an enforcement letter regarding this encroachment. Butte County is meeting with the developer to resolve this issue.

View of the housing track road cutting into the levees slope and toe.
